CALSPAN ON-SITE AIR BAG DEPLOYMENT INVESTIGATION

CALSPAN CASE NO. 93-8

VEHICLE #1 - 1991 CHEVROLET CORSICA LT (AIR BAG-EQUIPPED)

CRASH DATE - [REDACTED], 1992

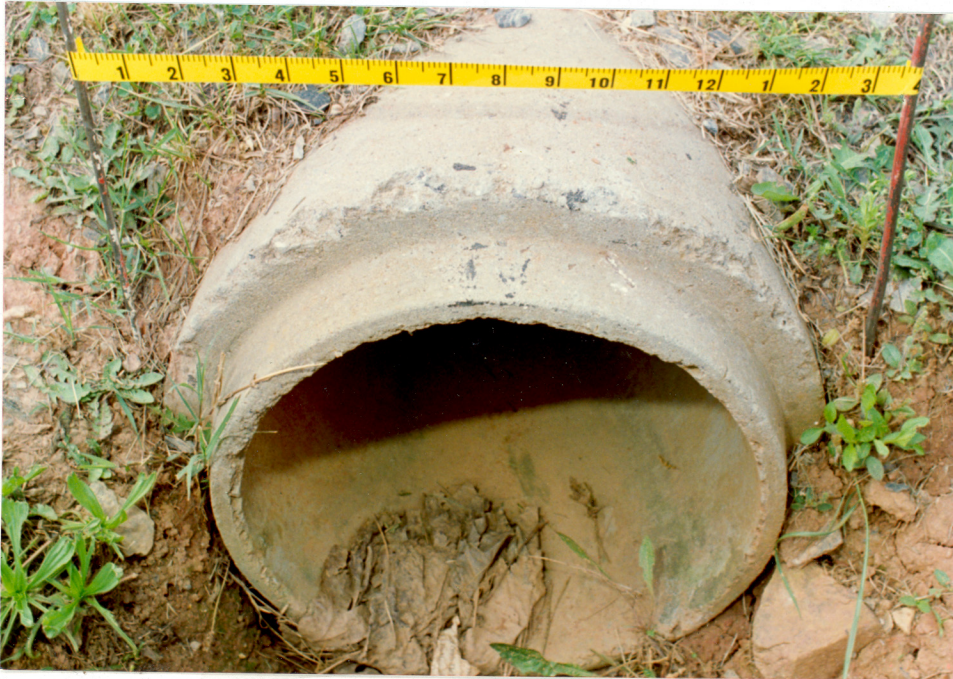
Following maximum engagement with the culvert, the vehicle overrode the drainage pipe as noted by black undercarriage transfer marks on the top surface of the pipe as shown in photographs #11 and #12. It continued to final rest position (FRP) approximately 0.9 cm (3.0') from the POI.

11. Close-up view of driveway culvert with yellow calibrated inch tape installed and depicting the overall pipe diameter of 40.6 cm (16.0").

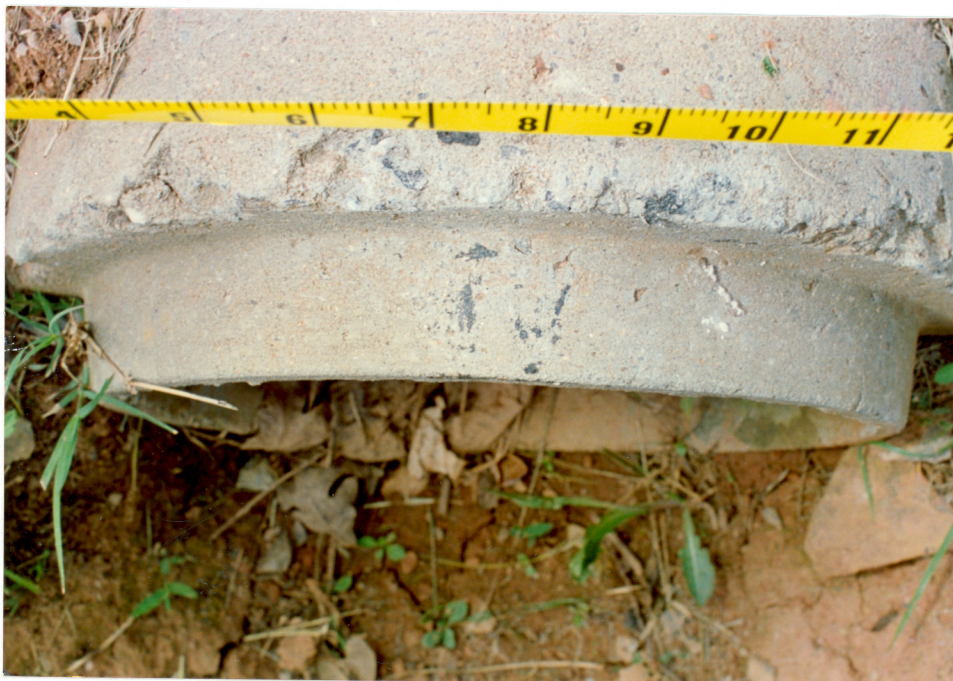
12. Overhead close-up view of driveway culvert showing black transfer marks from the vehicle's undercarriage.

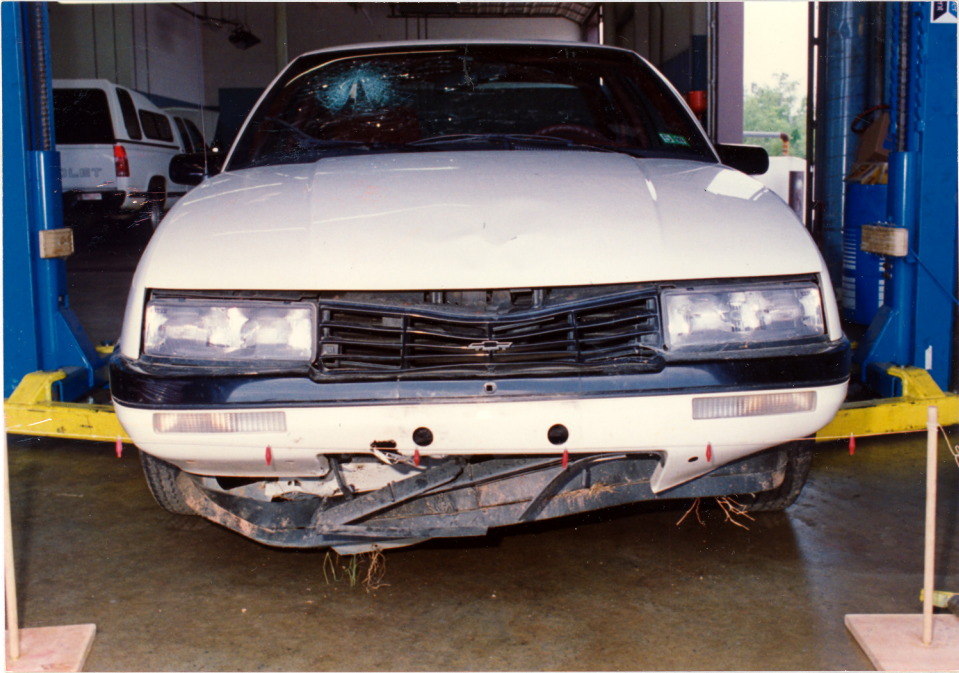
The right frontal plane of the 1991 Chevrolet Corsica LT impacted an open end of a 40.6 cm (16.0") drainage pipe which was designed to channel water under a residential driveway. Direct contact began 2.5 cm (1.0") right of the vehicle's centerline and extended 40.6 cm (16.0") toward the right front corner. The impact displaced the entire frontal structure rearward resulting in a combined direct and induced damage length of 135 cm (53"). Crush values obtained along the front bumper and along the lower radiator support frame member are listed below:

21. Overall view of the 1991 Chevrolet Corsica's frontal plane showing contact damage to the bumper and lower valence panel.

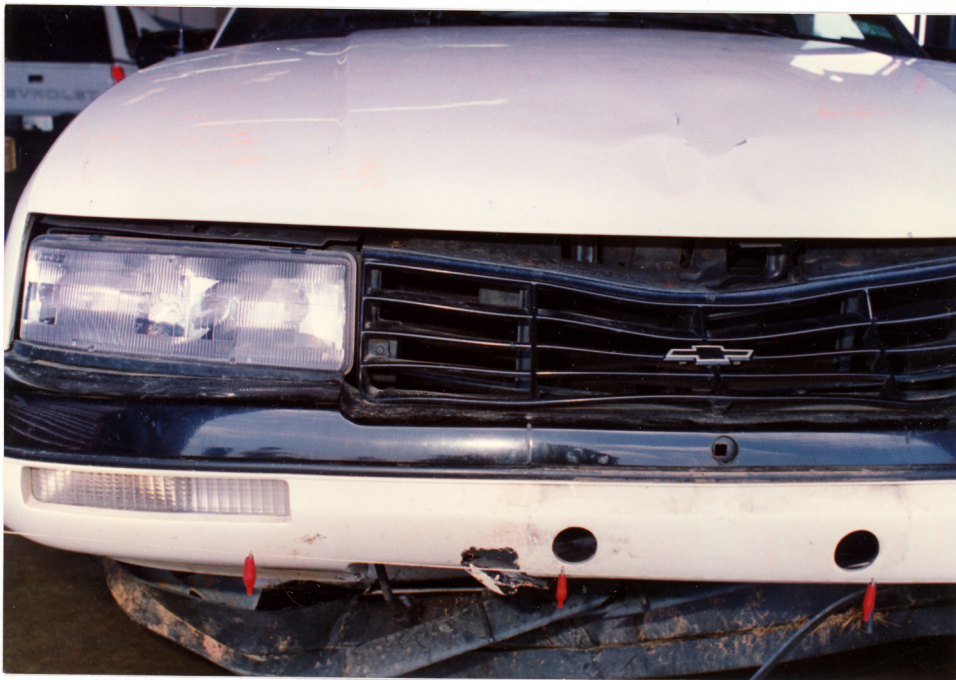
22. Right half of the vehicle's frontal plane highlighting contact on the bumper.

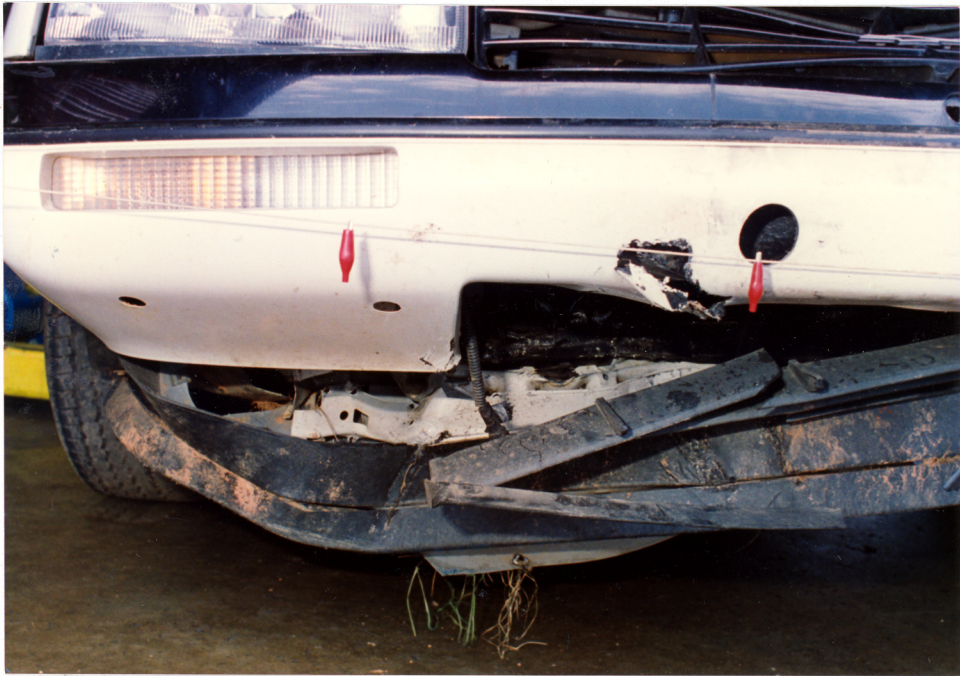
23. Close-up of contact damage on the bumper and lower valence panel.

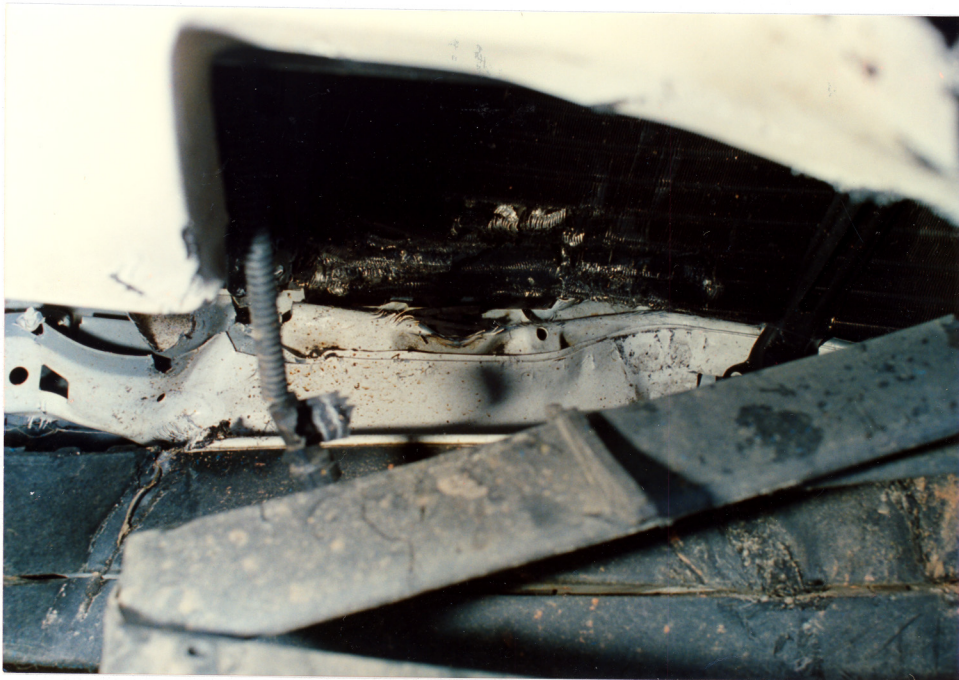
24. Close-up of the lower valence panel and radiator highlighting the contact pattern consistent with the driveway culvert design and dimension.

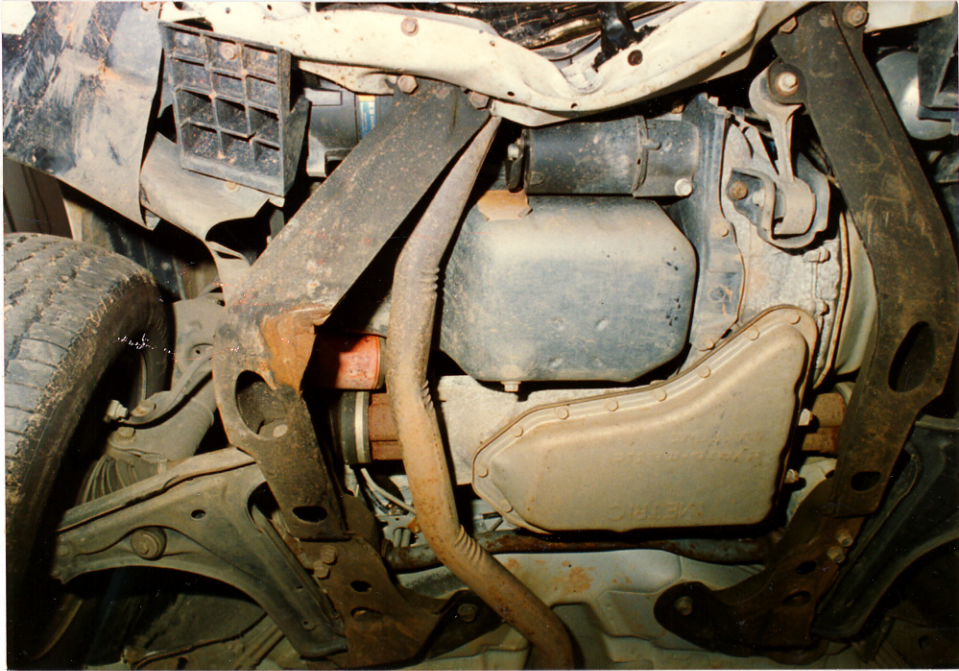
Components damaged in the crash included the front bumper, lower valence/air dam, radiator support bracket, radiator, both frame rails, grille panel, and windshield. The engine frame rails were displaced rearward with the right rail moved 11.4 cm (4.5") rearward and the left rail 2.5 cm (1.0") rearward. The right wheelbase was reduced by 2.3 cm (0.9"). The front bumper energy absorption devices (EAD) compressed during the crash with 1.6 cm (0.6") of stroke noted on the right side and 1.0 cm (0.4") of stroke on the left side. Both EADs returned to full restitution at 11.4 cm (4.5").

29. View of undercarriage showing rearward displacement of frame rails. The top of the photo shows the culvert contact damage on the front lower valence panel while the right frame rail is seen along the left side of the photograph.

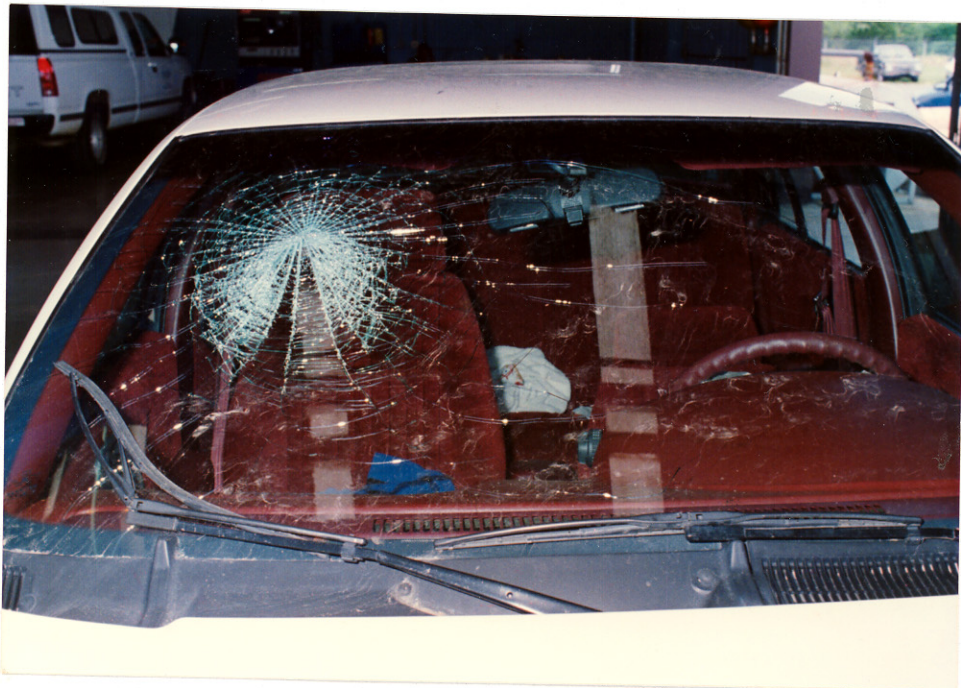
The right front passenger was sitting on the seat cushion and moved straight forward striking her knees on the lower instrument panel. Her head contacted the windshield resulting in a typical spider web pattern and producing an inverted "V" tear in the laminate. She rebounded back toward her seat and may have come in contact with her mother and emesis on the seat cushion. The passenger climbed into the rear seat area between the front seat back rest and most likely contacted the right sunvisor and roof during this activity. Additionally, emesis noted on the left side of the right front seat back rest may have been transferred from the passenger's clothing during her egress activity. She was assisted from the vehicle through the left rear door by local residents.

32. View of windshield contact by right front occupant.

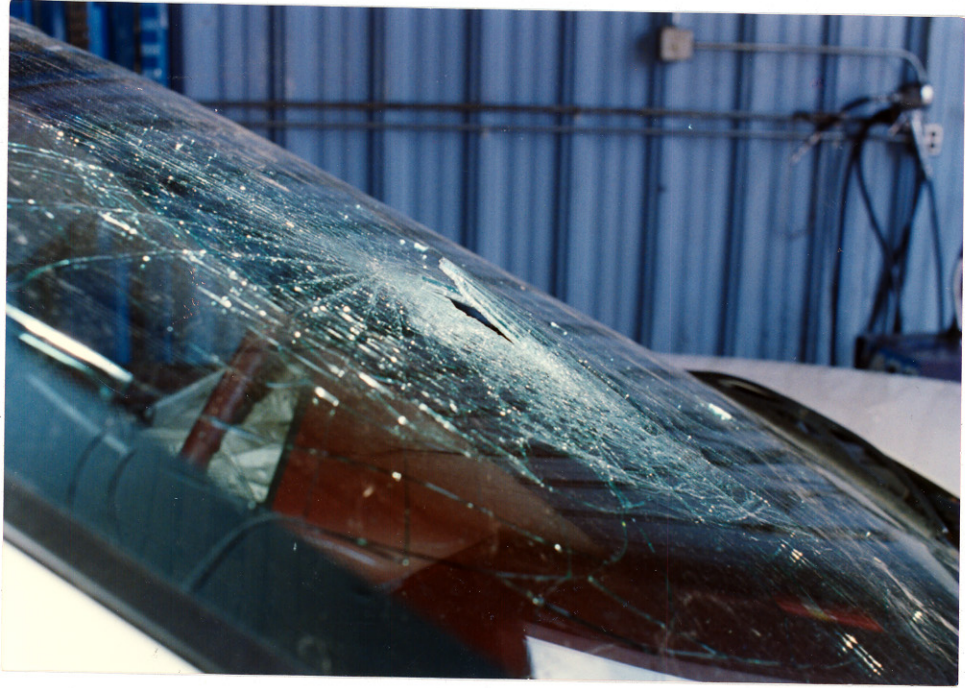
The right front passenger moved forward and contacted the instrument panel with her knees and windshield with her head which resulted in a 7.6 cm (3.0") by 6.4 cm (2.5") tear of the windshield laminate. She sustain an avulsion, abrasions, and contusions of the forehead and an avulsion and contusion of the right knee. Witnesses (residents of the area) found the

33. Close-up lateral view showing windshield laminate tear from contact by right front occupant.

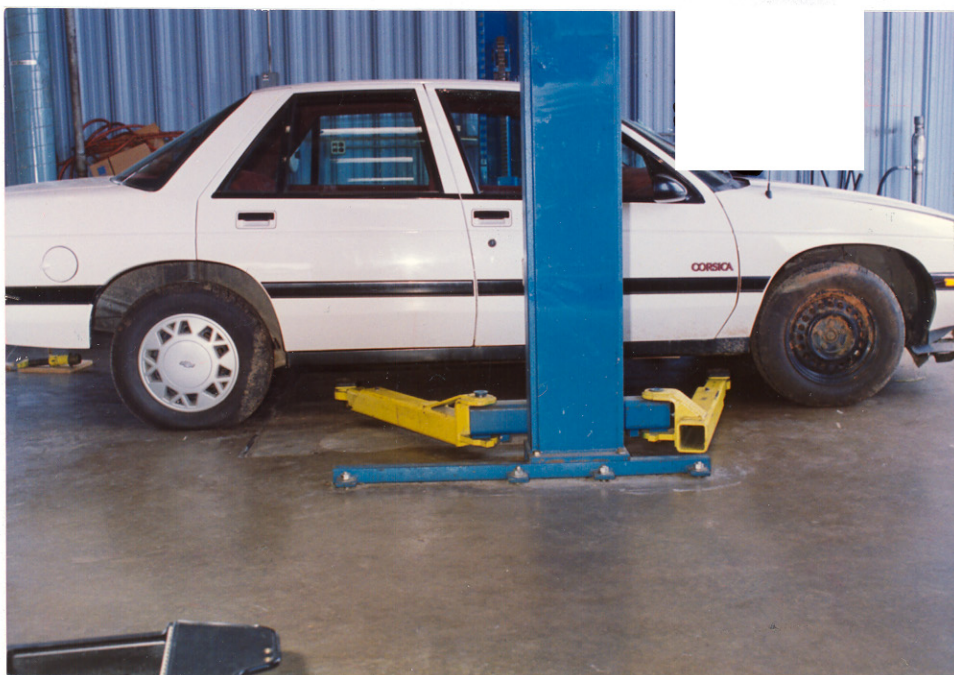
At the beginning of the vehicle inspection, the position of the steering wheel was noted in 100 degrees counter clockwise position. This position appeared consistent with on-scene photographs of the vehicle interior. The rotation probably occurred as a consequence of the impact with the drainage pipe and accentuated by the interaction of the right front tire with the side of the ditch.

40. View of right side plane showing ditch contact evidence on the right front tire and wheel.

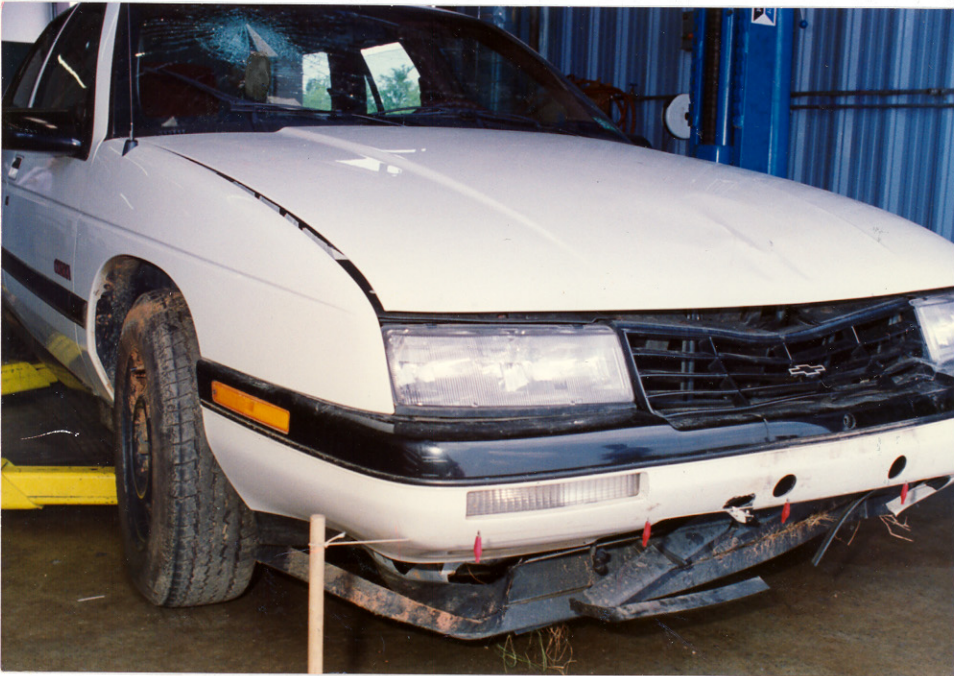
41. Right front corner view showing contact damage to bumper and lower valence panel.

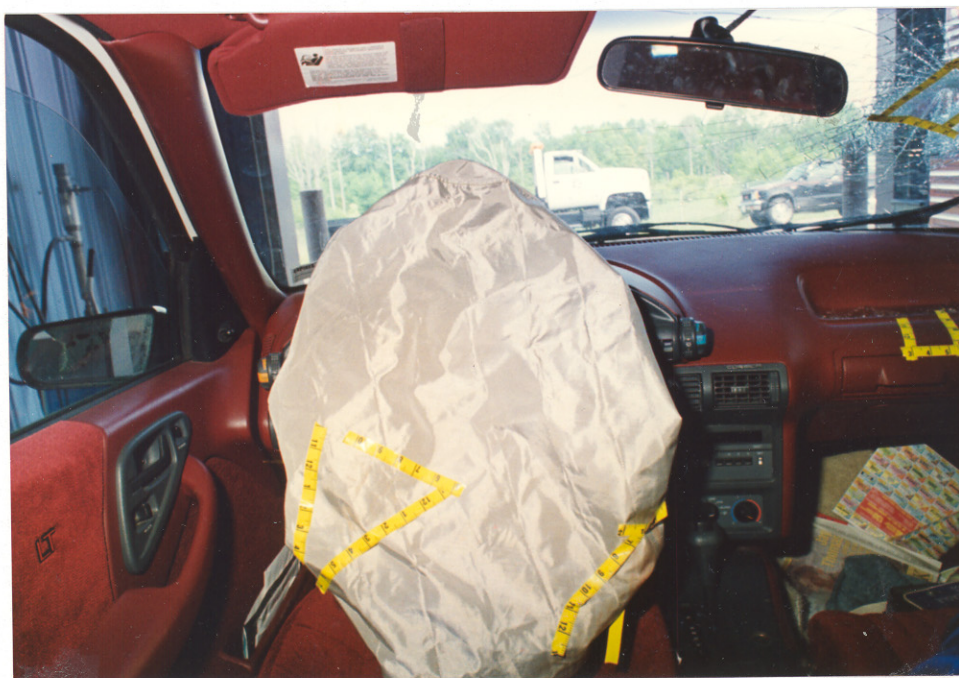
43. Overall view of the driver's air bag and contact points (steering wheel rotated approximately 100 degrees CCW).

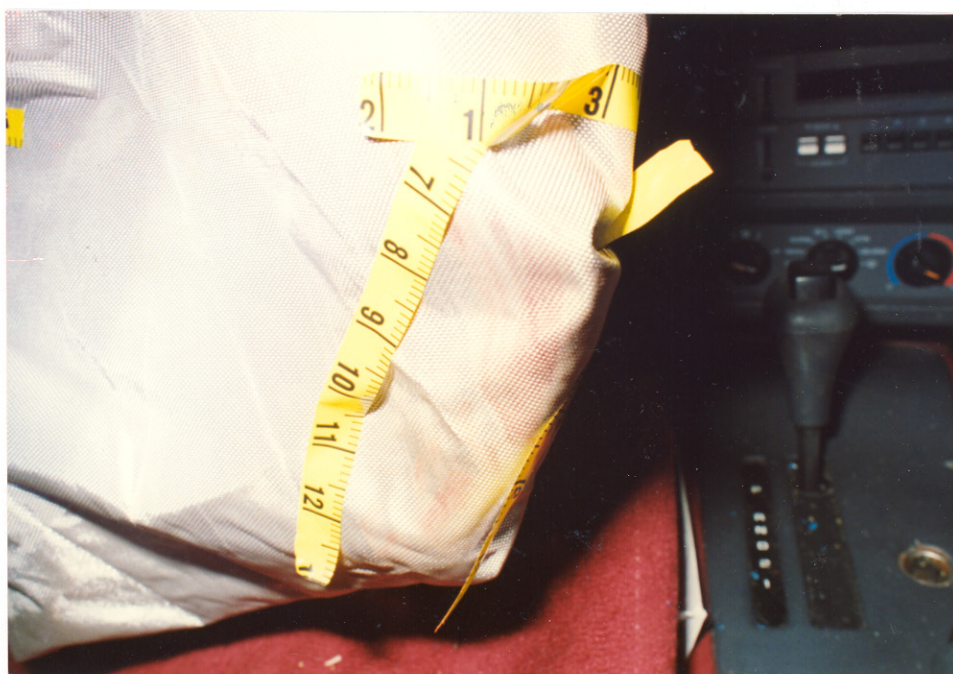
44. Close-up of bodily fluid transfer on lower left quadrant of air bag.

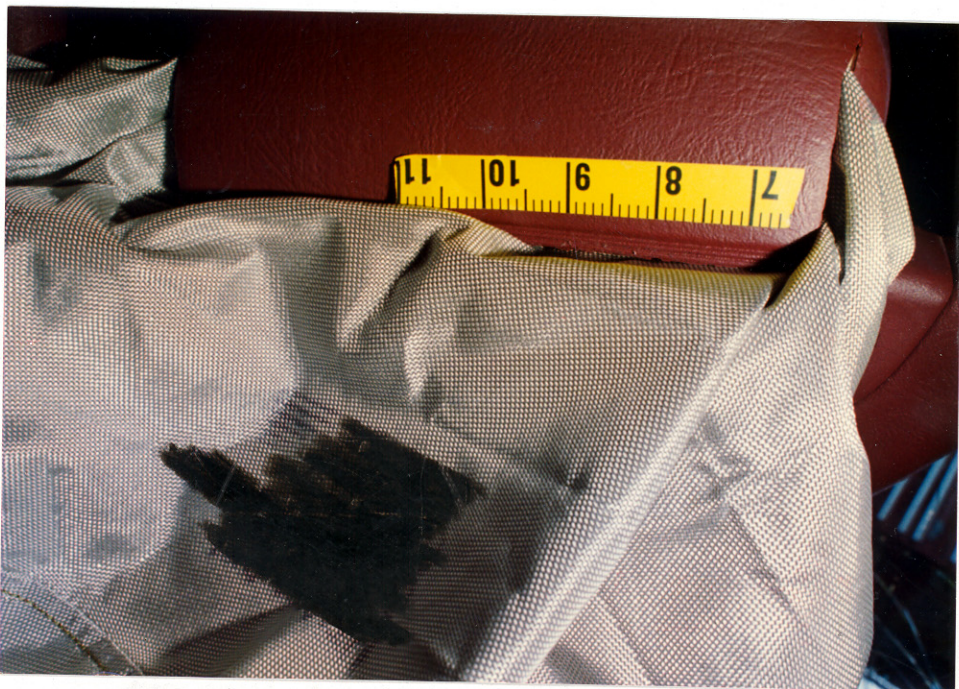
A tissue transfer located along the lateral seam line of the upper module flap began at the bottom right corner and extended 7.6 cm (3") to the left. This was attributed to contact with the driver's neck during the air bag deployment sequence. Strands of hair associated with the driver's head were observed wedged in the lower right corner of the Chevrolet insignia. This was attributed to contact by the lower flap during the deployment sequence.

46. View of upper air bag module flap showing tissue transfer along seam break.

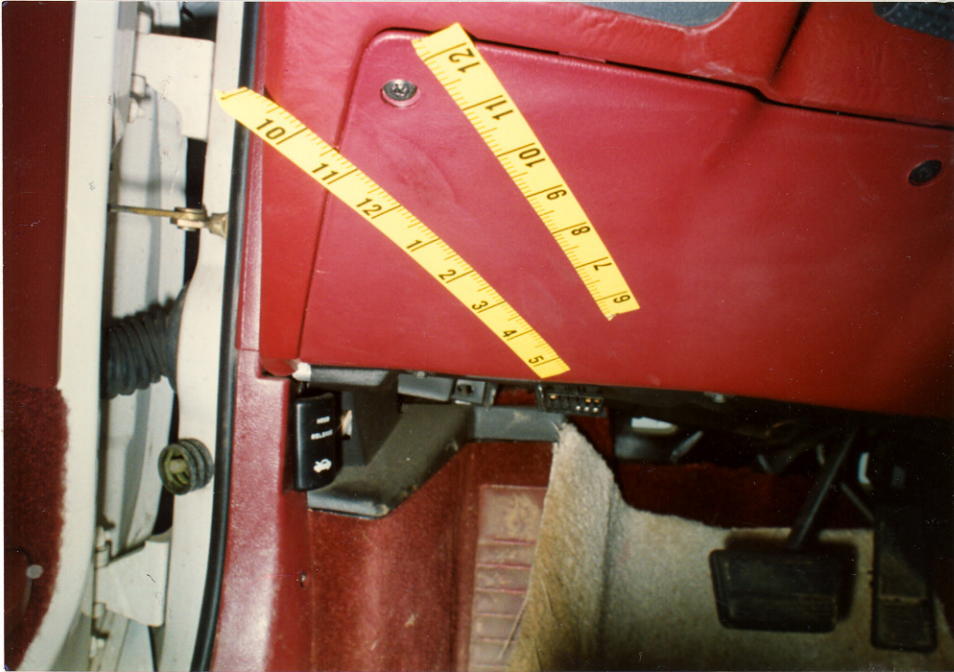
The driver was thrust rearward and contacted the seat back rest. She rebounded and contacted the lower instrument panel with her left knee which was noted by a 20.3 cm x 3.8 cm (8.0" x 1.5") scuff mark located 48.3 cm (19.0") left of the vehicle centerline (refer to photograph #47). She then contacted the inflated air bag a second time with her upper body and subsequently moved rearward and to the right as the result of the vehicle's final rest attitude (i.e., canted to the right along the ditch slope). The driver's body slumped to the right across the center console with the right side of her head coming to rest on the right front seat cushion facing forward. The driver's right arm was outstretched toward the right front door surface and situated under her head. Her lower body remained in the driver seat with her hips and thighs located toward the right side of the driver's seat cushion with her knees near the instrument panel between the steering column and console. Her right foot appeared to be resting on the floor pan and the left foot positioned diagonally toward the left side kick panel (refer to photographs #61 and #62).

47. Scuff pattern on surface of knee bolster by driver's left knee.

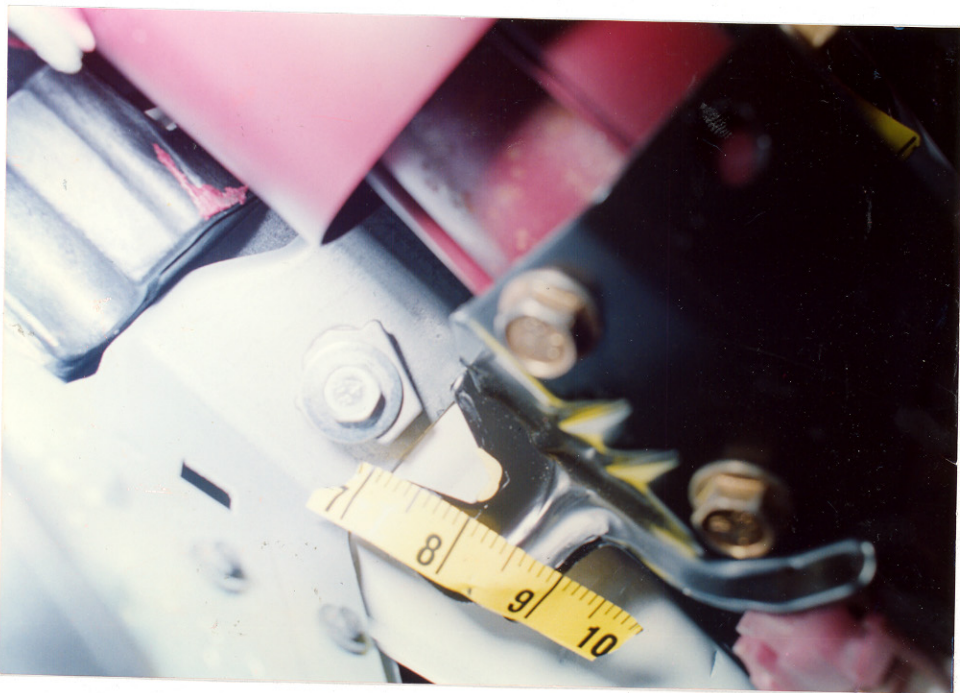
50. View of left shear capsule/shear plate showing 2.5 cm (1.0") of longitudinal movement.

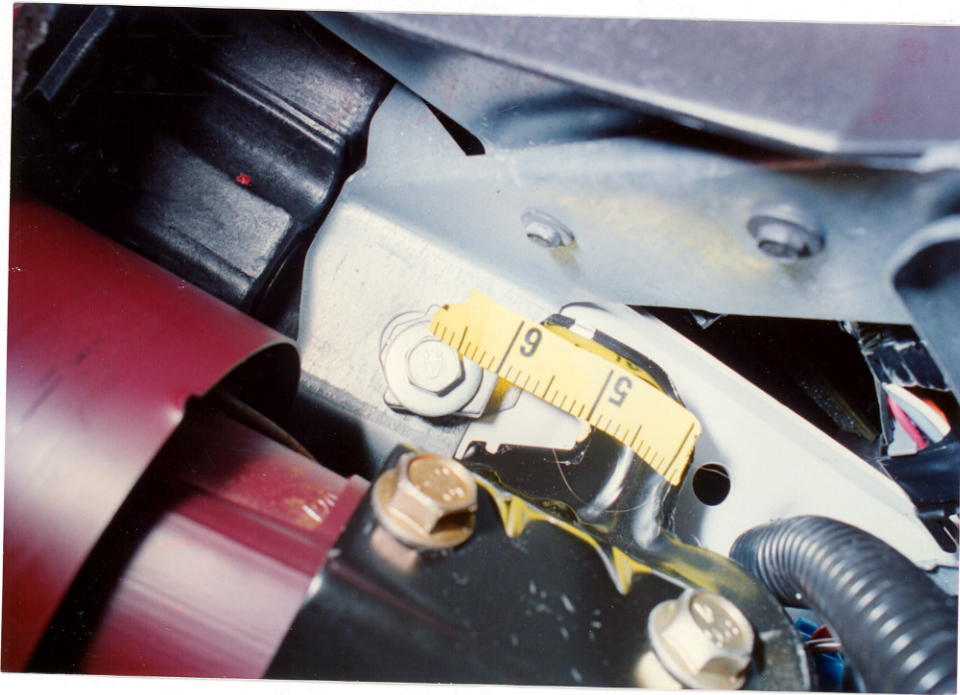
51. View of right shear capsule/shear plate showing 2.5 cm (1.0") of longitudinal movement.

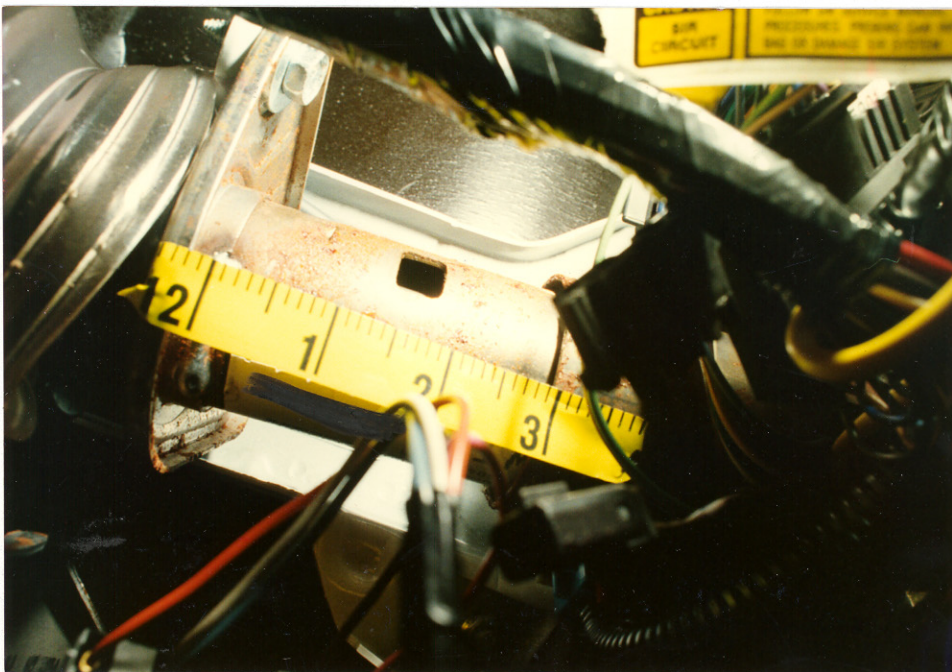
52. View of steering column EAD with 1.90 cm (0.75") of compression. The post crash measurement from female end to flange was 8.30 cm (3.25").

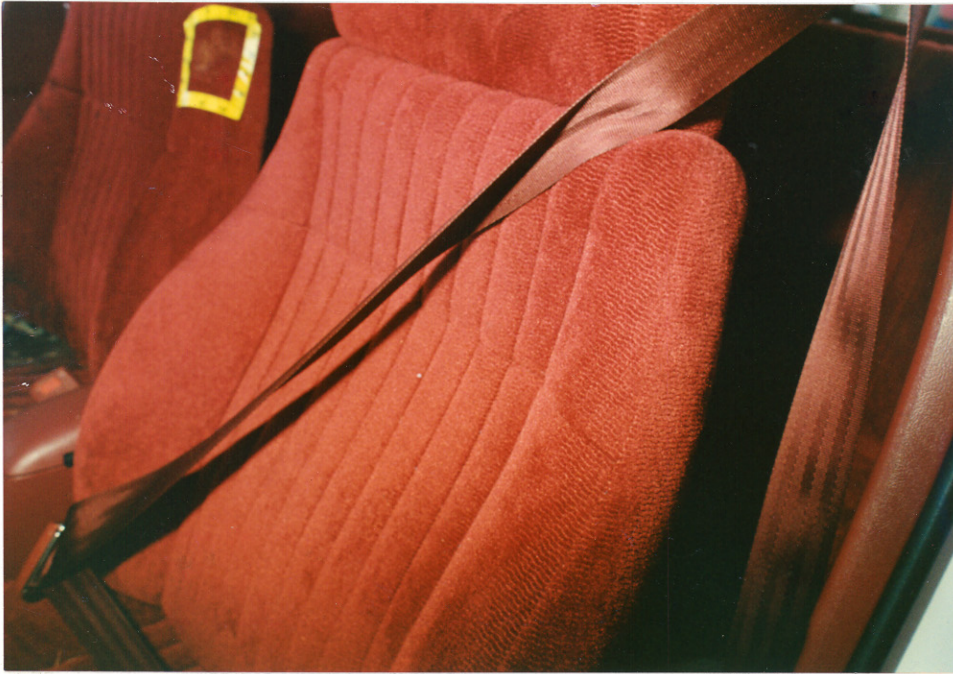
53. The driver's seat back rest with 3 point manual belt engaged to illustrate the lack of usage in crash.

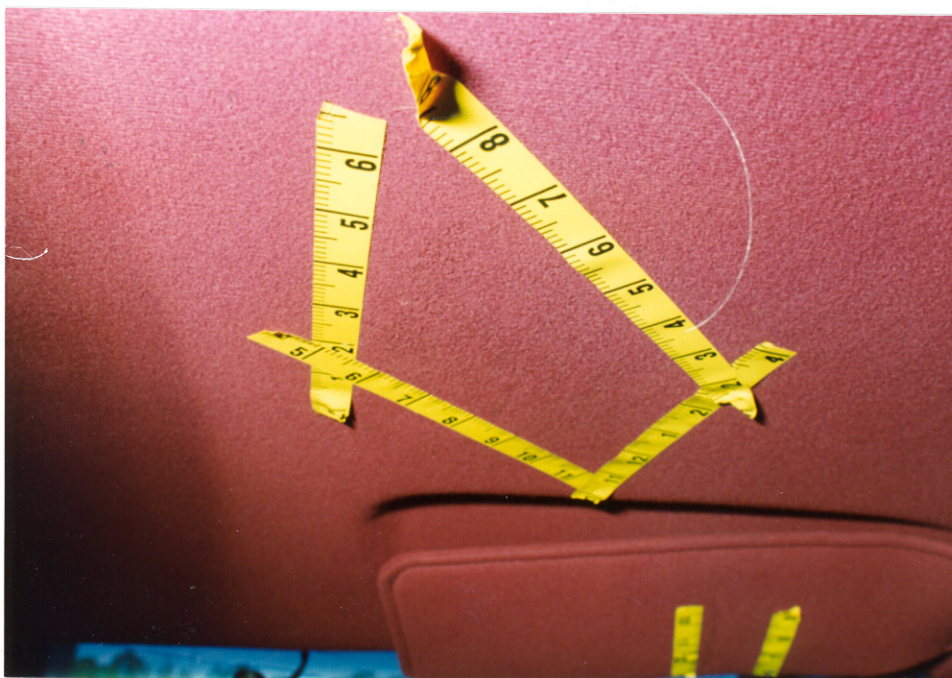
The roof liner fabric was abraded above the right front passenger's seat. This area measured 12.7 cm by 14.0 cm (5.0" x 5.5") and was located 17.8 cm (7.0") right of the vehicle centerline. The abraded mark also appeared to have a bodily fluid stain which was attributed to contact by the right front occupant during egress activities.

55. Abraded surface of roof liner fabric.

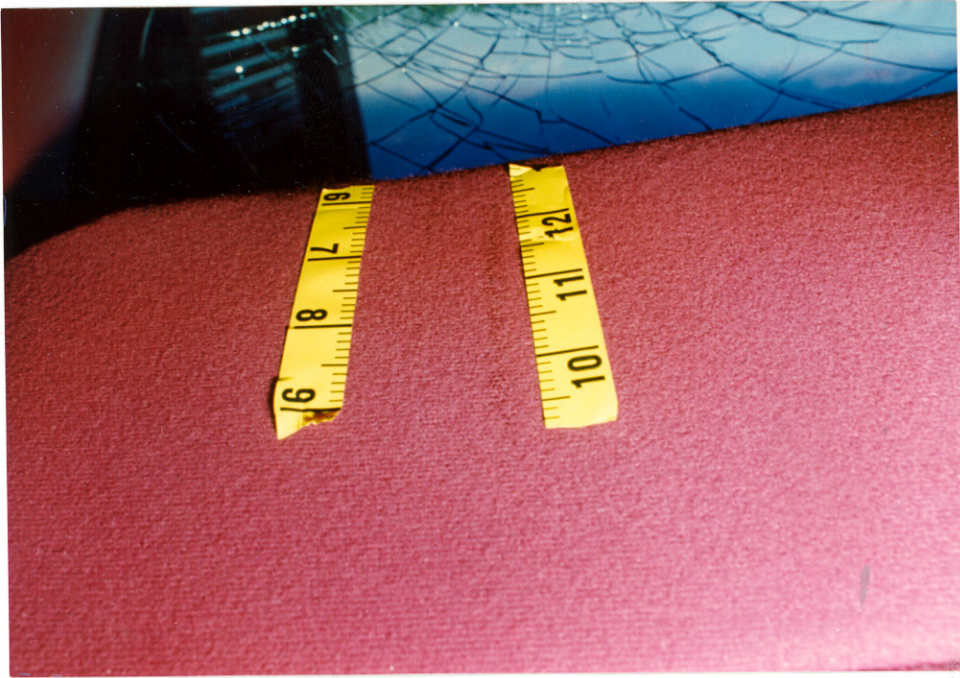
A smudge mark attributed to the passenger's upper torso was noted on the upper edge of the mid-instrument panel below the windshield. A bodily fluid transfer on the right sunvisor located 36.6 cm (14") right of the centerline was attributed to post-impact contact by the right front passenger. She was described by witnesses as covered with bodily fluid and found in the rear seat area.

57. Close-up view of right front occupant contact on right sunvisor.

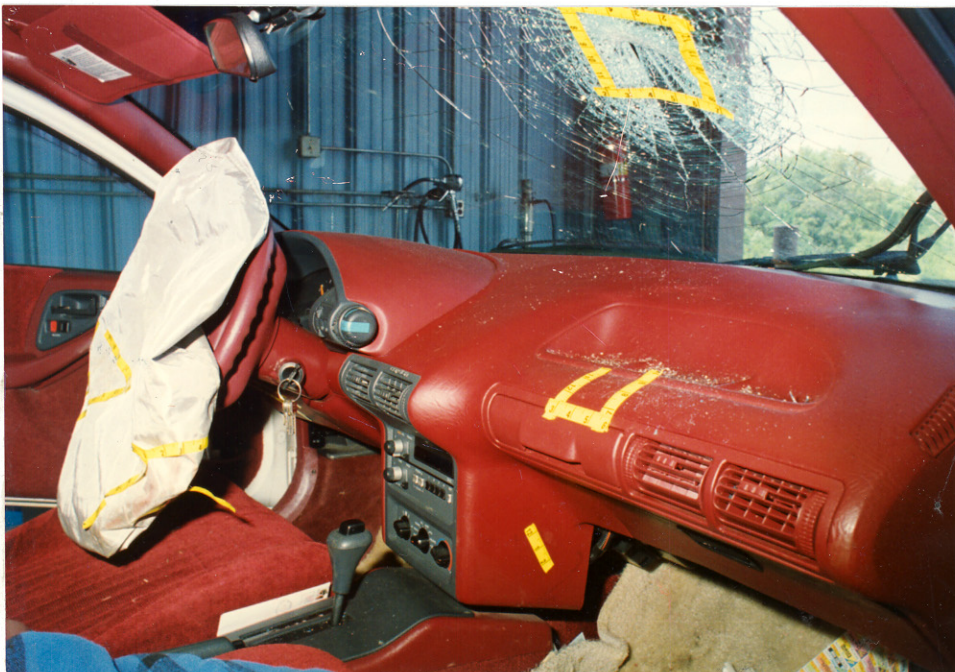
58. Angular view of the right instrument panel highlighting right front occupant contacts on the windshield and upper instrument panel.

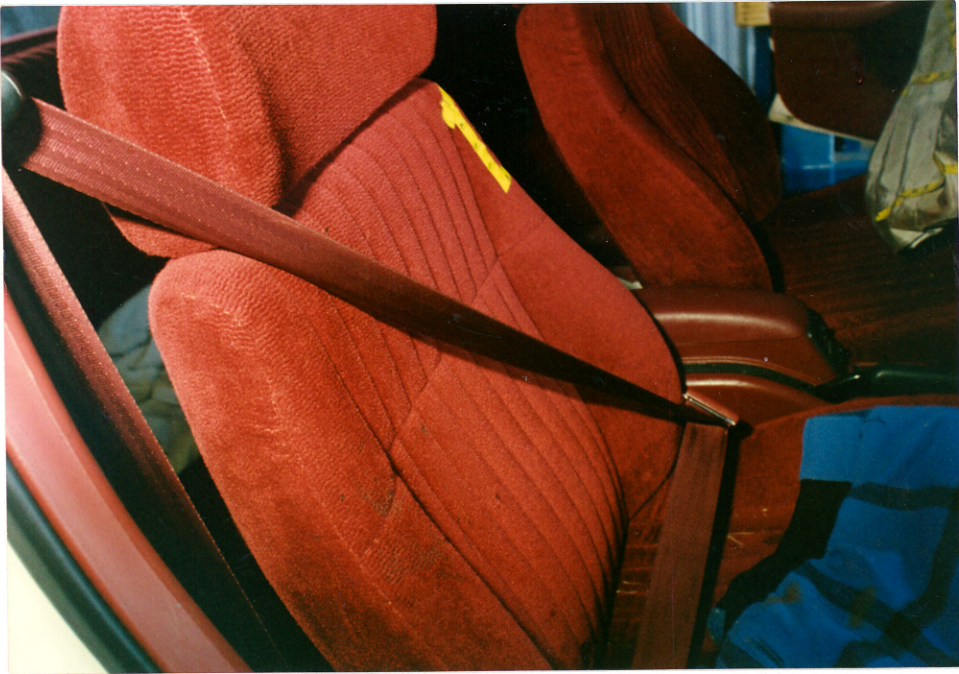
59. View of the right front seat with the 3 point manual restraint belt engaged to illustrate lack of usage in crash.
